Colonial Pipeline CR251 Rupture Pelham, Shelby County, Alabama Situation Report #3

November 2, 2016

NRC #1162982

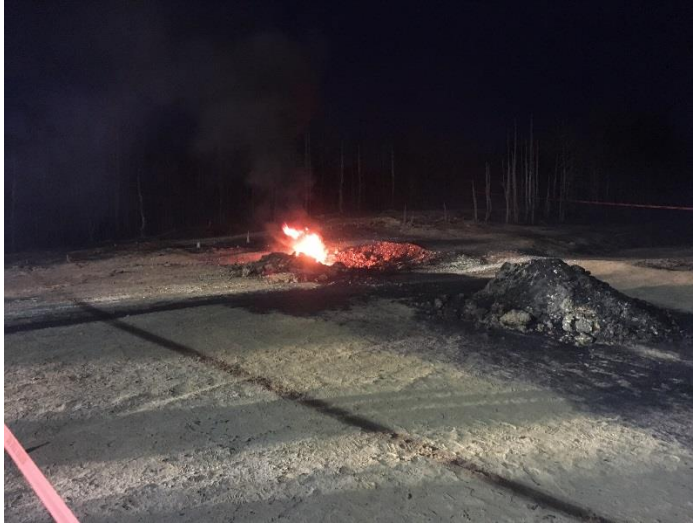
Figure 1.

This image shows the pipeline fire drastically reducing in size.

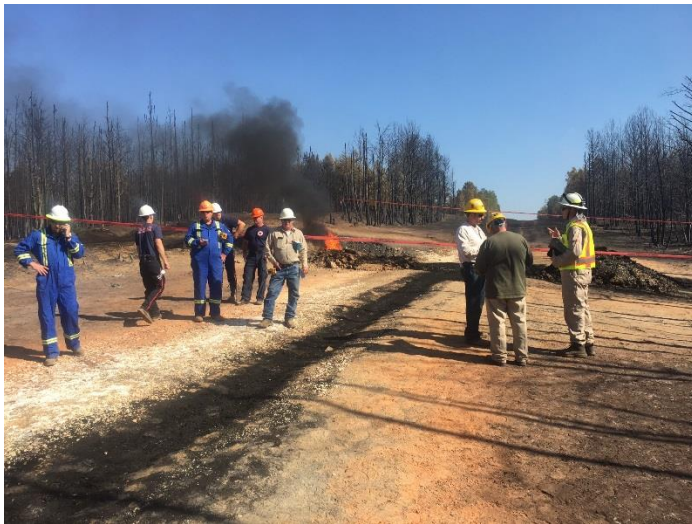
Figure 2.

Responders at the site.
